Using A Lithium Disilicate Material To Restore Fractured Anterior Teeth

Joseph Barton, DMD, LVIM

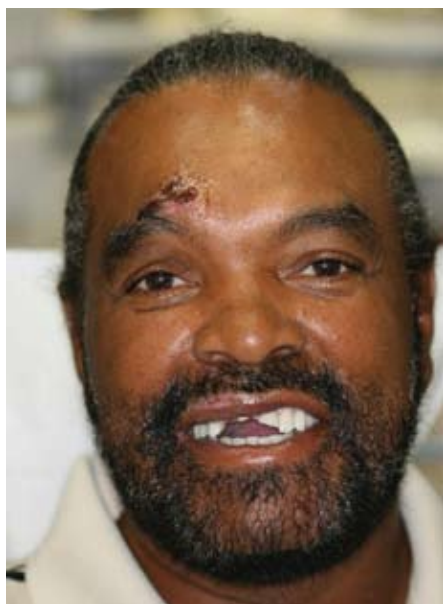
Figure 1. Preoperative view of a 61-year-old male patient who presented with dental trauma after being knocked off balance on his scooter and landing face first on the throttle.

A 61-year-old male presented after sustaining injuries from a fall while riding a Vespa scooter. He was knocked off balance by an automobile and landed face first onto the throttle of his scooter (Figure 1). The impact resulted in multiple soft tissue abrasions and three fractured anterior dentition (Figure 2). Tooth #7 had a previously treated root canal, a crown that appeared to be fractured below the gum line, and was deemed non-restorable. Tooth #8 had broken off at the gingival level, exposing the pulp but leaving sufficient ferrule for restoration. Tooth #9 had a clinical crown that was fractured in half without pulp exposure (Figure 3).

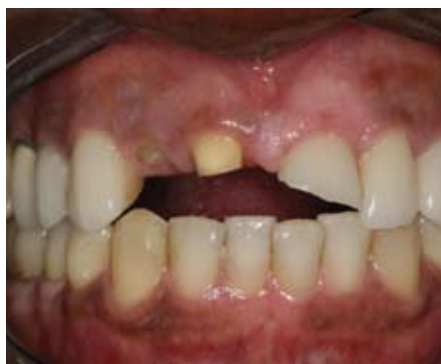
Figure 2. Preoperative retracted close-up view of the patient's trauma revealing multiple soft tissue abrasions and three fractured anterior dentition.

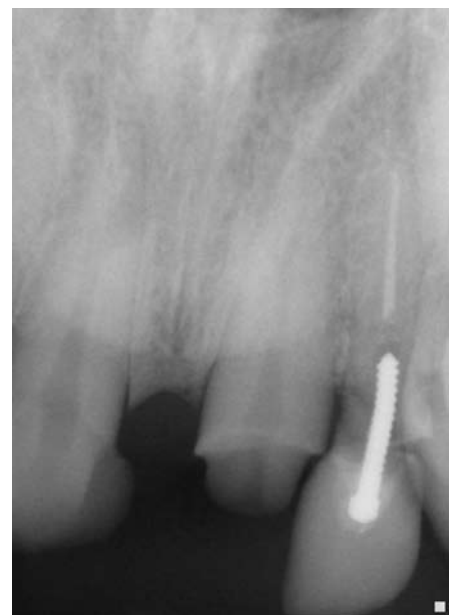
Figure 3. Radiographic view revealing the extent of the damage.

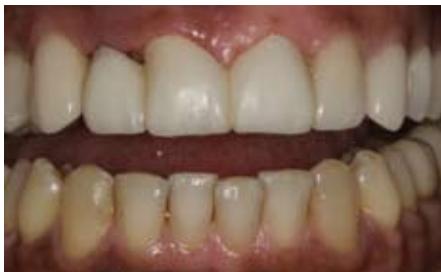
Figure 4. View of the temporary restorations prior to extraction.

The crown on tooth #7 was removed. A cantilever bridge was fabricated with an abutment on tooth #8 (e.g., a fibercore post was used as a temporary post in order to support the bridge), an abutment on tooth #9, and a pontic on tooth #7 over the temporarily retained root. The temporaries were seated using a temporary cement (Temp Bond NE, Kerr) (Figure 4).

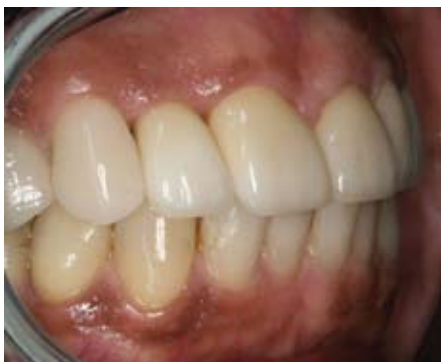
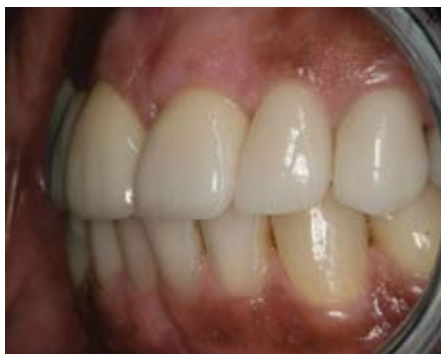
Figure 5. Close-up right lateral view of the patient's restorations.

Figure 6. Close-up left lateral view of the patient's restorations.

Prior to the extraction of the root of tooth #7, the provisional restoration was removed. A 4.0 x 15 mm implant (Astra) with a healing abutment was placed immediately (Figures 5 and 6). Allograft putty (RegnerOss) was placed adjacent to the implant. The temporary cantilever bridge was re-cemented (Temp Bond NE) to allow osseointegration of the implant.

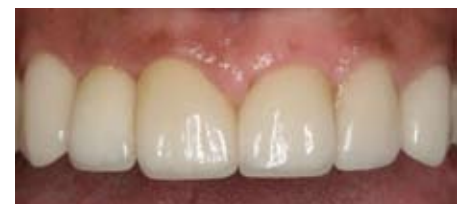
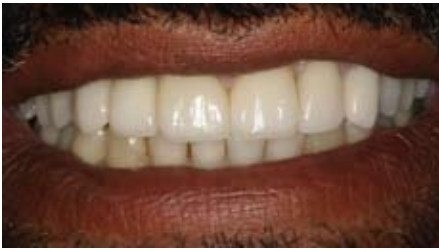
Figure 7. Close-up view showing tissue response.

Figure 8. Postoperative close-up view of the patient's full smile.

The IPS e.max crown restorations for teeth #7, #8, and #9 were adhesively bonded into place. First, the teeth were rinsed with an antimicrobial scrub (Consepsis), and the inside of the crowns and zirconium abutment were silanated (Monobond S). A uni-

versal cement primer (Multilink a+b, Ivoclar Vivadent) was mixed and applied to the natural tooth structure. A self-curing resin cement for implants (Multilink Implant Automix) was then placed inside the crowns, which were seated using firm pressure.

Excess cement was removed using a rubber tip and then light-cured using an LED curing light. After receiving patient approval of the final esthetics, photographs of the definitive restorations were taken (Figures 7 and 8).

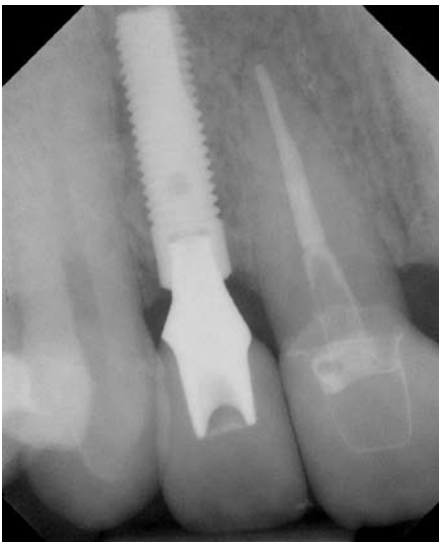
Figure 11. Postoperative radiograph showing the implant with the abutment and crown and the adjacent custom post and crown in place.

During the follow-up appointment (Figures 9 and 10), the patient’s occlusion was checked in centric and functional chewing movements, and radiographs were obtained to confirm cement removal (Figure 11). The patient approved of the final esthetics and recalled his pre-treatment condition: “After my motorcycle accident, I was a mess and thought I’d never look the same again. My wife said, ‘I just want your beautiful smile back!’ So we called Dr. Barton, and he really did give me my smile back!”
